July 9, 2015

Subject: Red and Bonita Mine, Silverton, CO
Site Visit Summary and Ground Control Plan

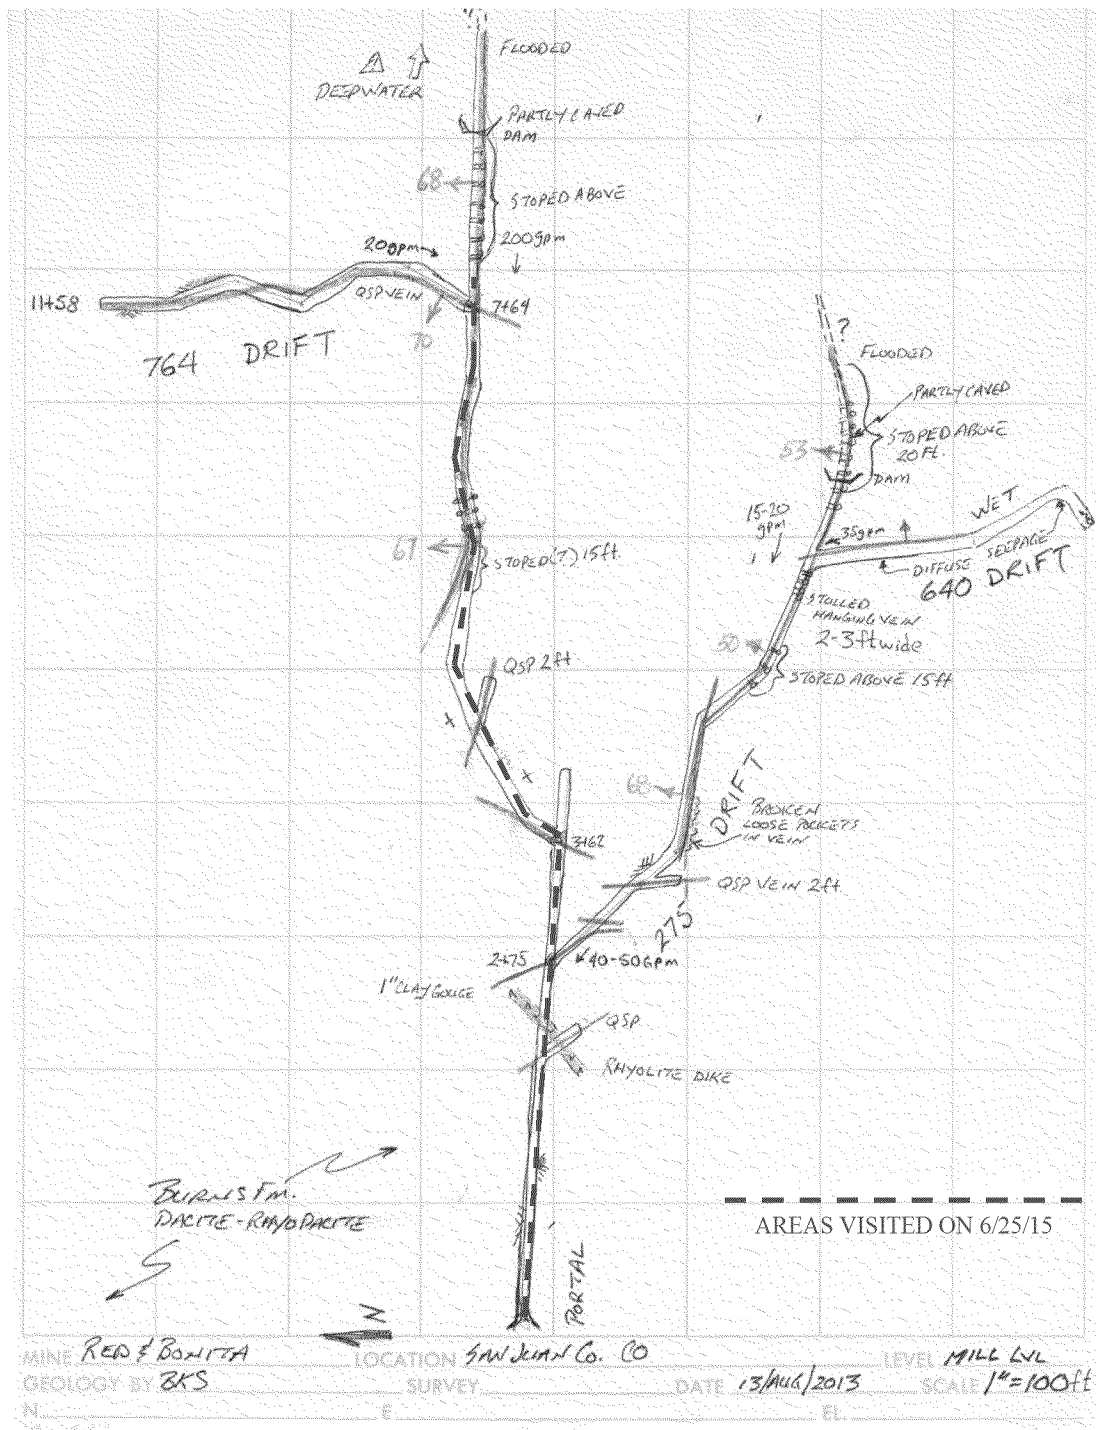
Figure 1: Detailed Map of Underground Workings
(modified from DRMS Red and Bonita Mill Level Survey Map; 2013)

The work areas visited are marked on the DRMS map of underground workings of the Red and Bonita Mine below:

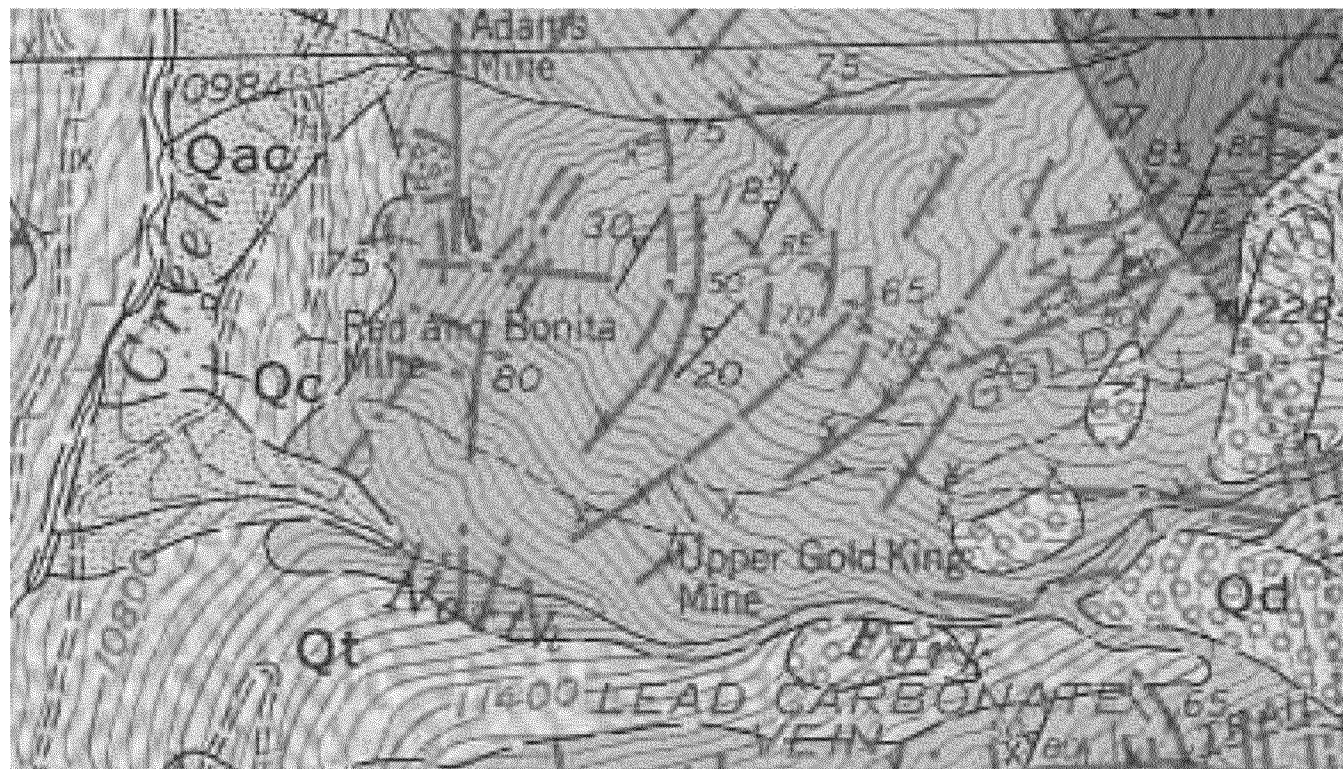
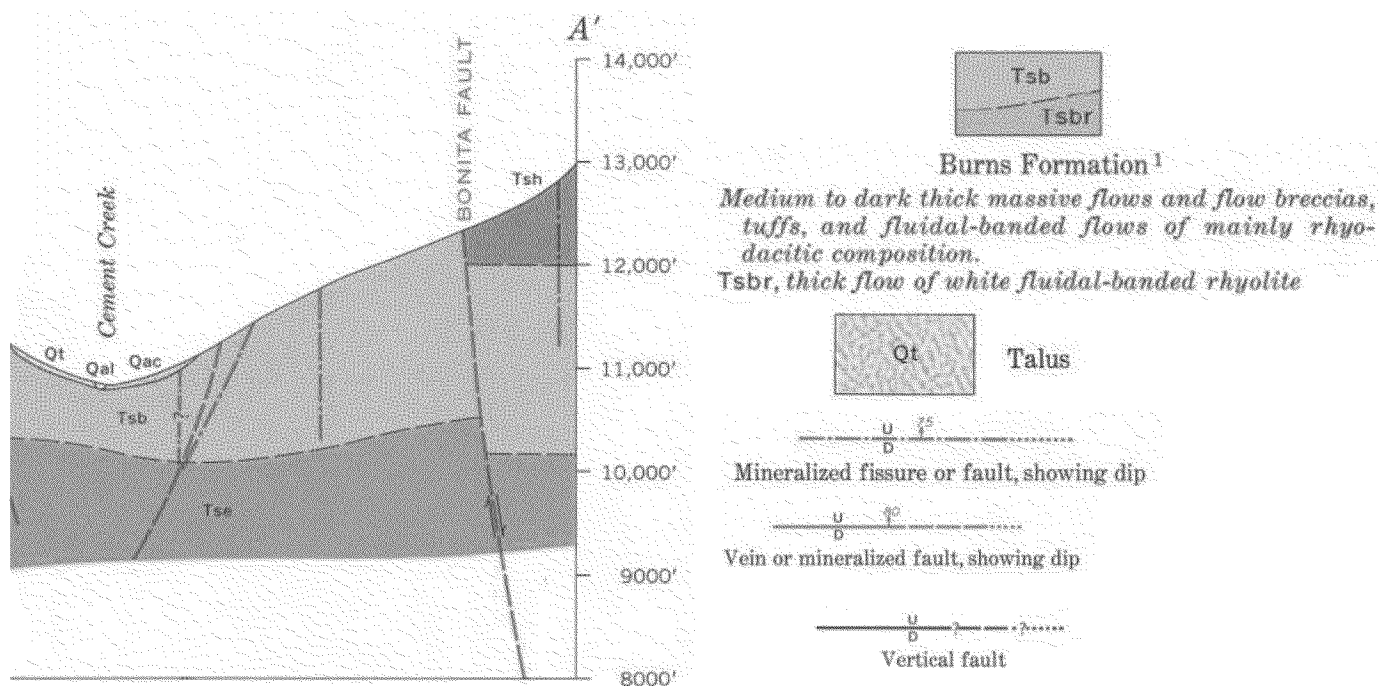
Figure 2: Geology and Rock Description (per USGS *Geology of the Ironton Quadrangle* (Burbank & Luedke; 1964)

The majority of the mine drifts viewed are currently unsupported with only two limited areas supported by timber: a single stull with overhead lagging exists at the junction of the main adit drift with the northern heading and a more extensive zone of stulls, rib sets, and lagging exists on the northern drift. The host rock consists of the Burns Formation of the Silverton Volcanic Group per the USGS *Geology of the Ironton Quadrangle* (1964):

Per the geologic map, there is considerable variation in the local orientations of the fissures, faults, and veins in the vicinity of the Red and Bonita Mine and this was apparent within the tunnel with various sections of the tunnel demonstrating prominent jointing and others exhibiting random jointing. Due to the considerable variation in jointing, no discontinuity measurements were taken during the site visit.
